SNOW SAMPLING SURVEY
in the vicinity of
KIMBERLY-CLARK OF CANADA LIMITED
and
WELDWOOD OF CANADA LIMITED,
LONGLAC

FEBRUARY, 1983

TECHNICAL SUPPORT SECTION
NORTHWESTERN REGION
ONTARIO MINISTRY OF THE ENVIRONMENT

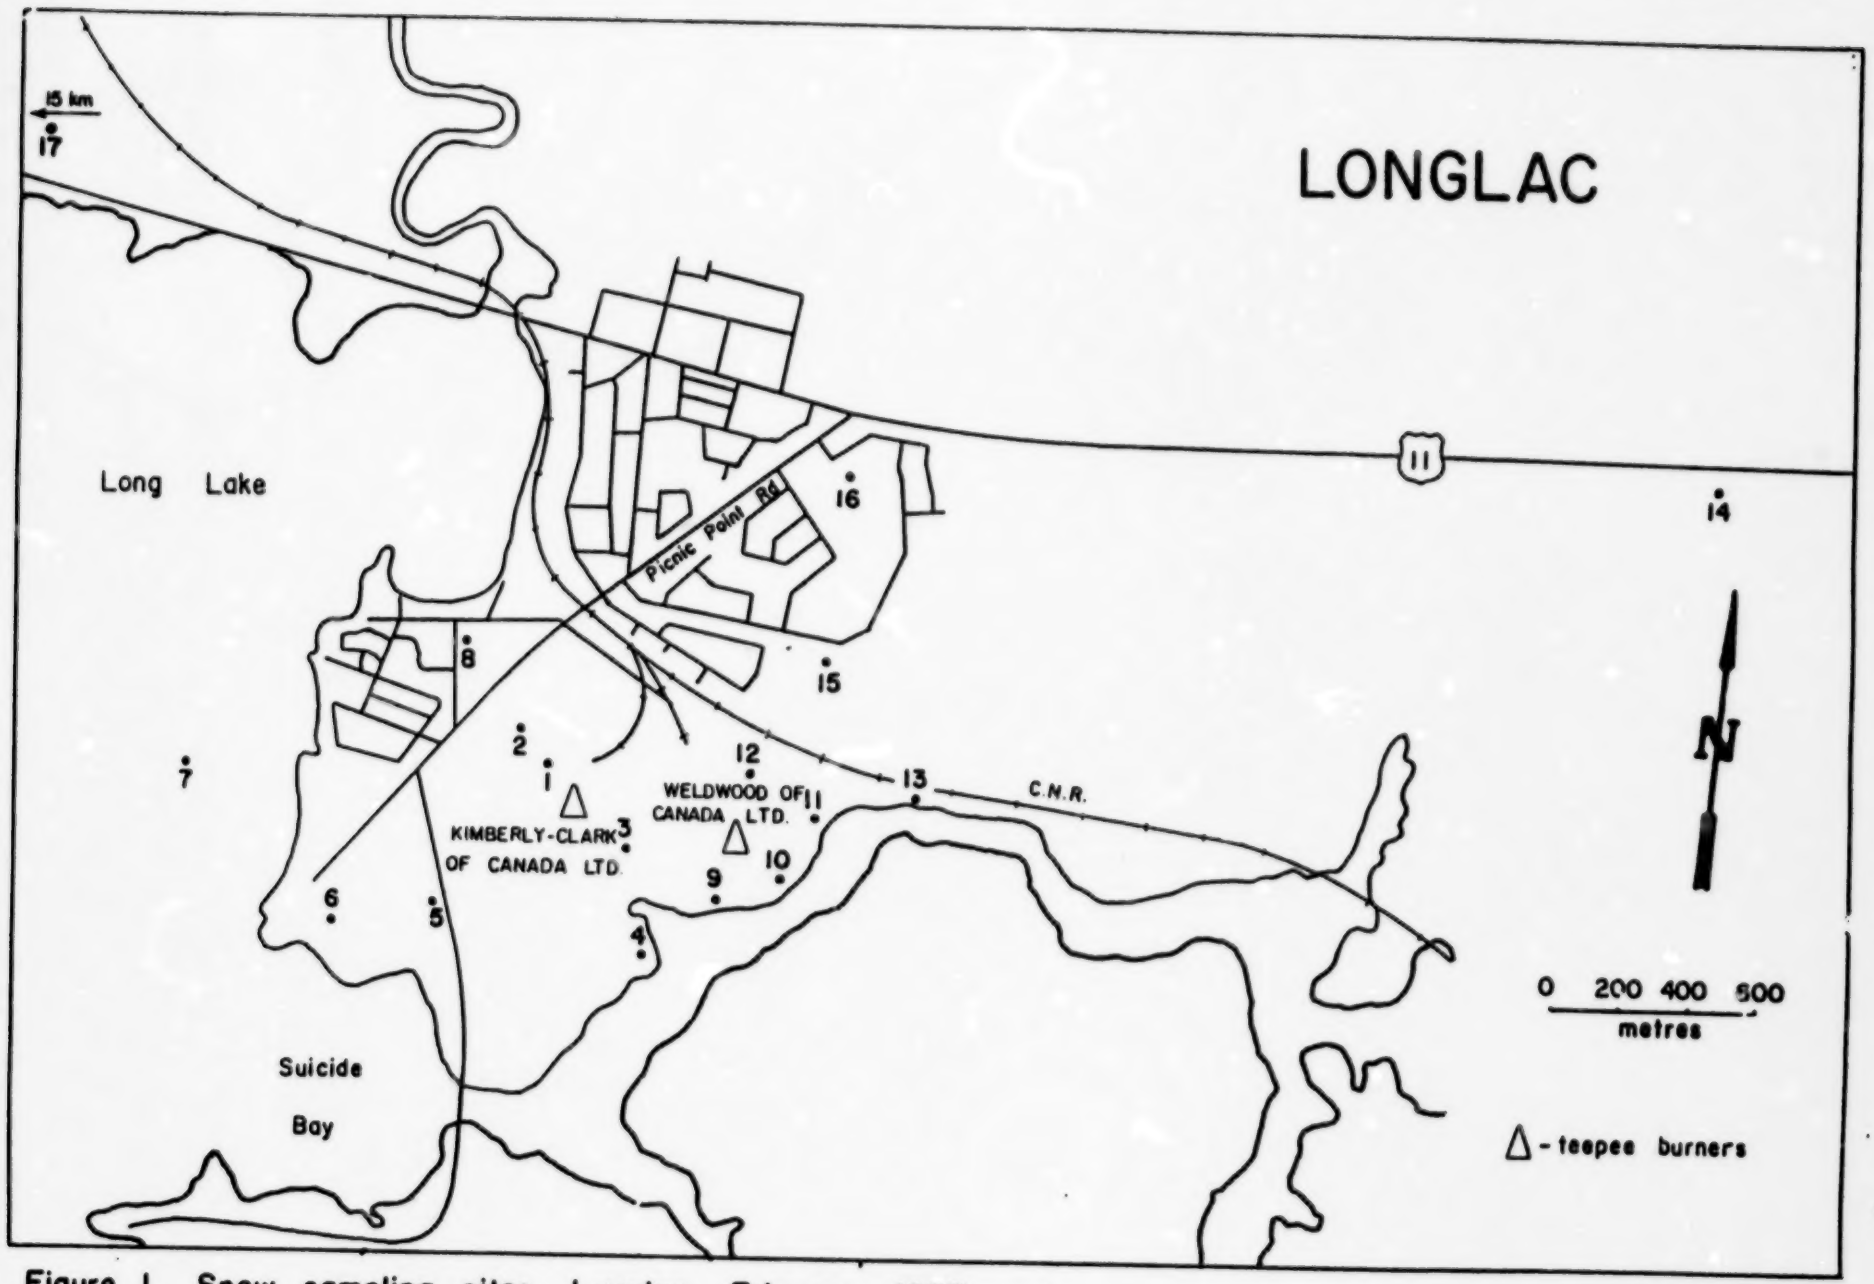
Figure 1. Snow sampling sites, Longlac, February, 1983.

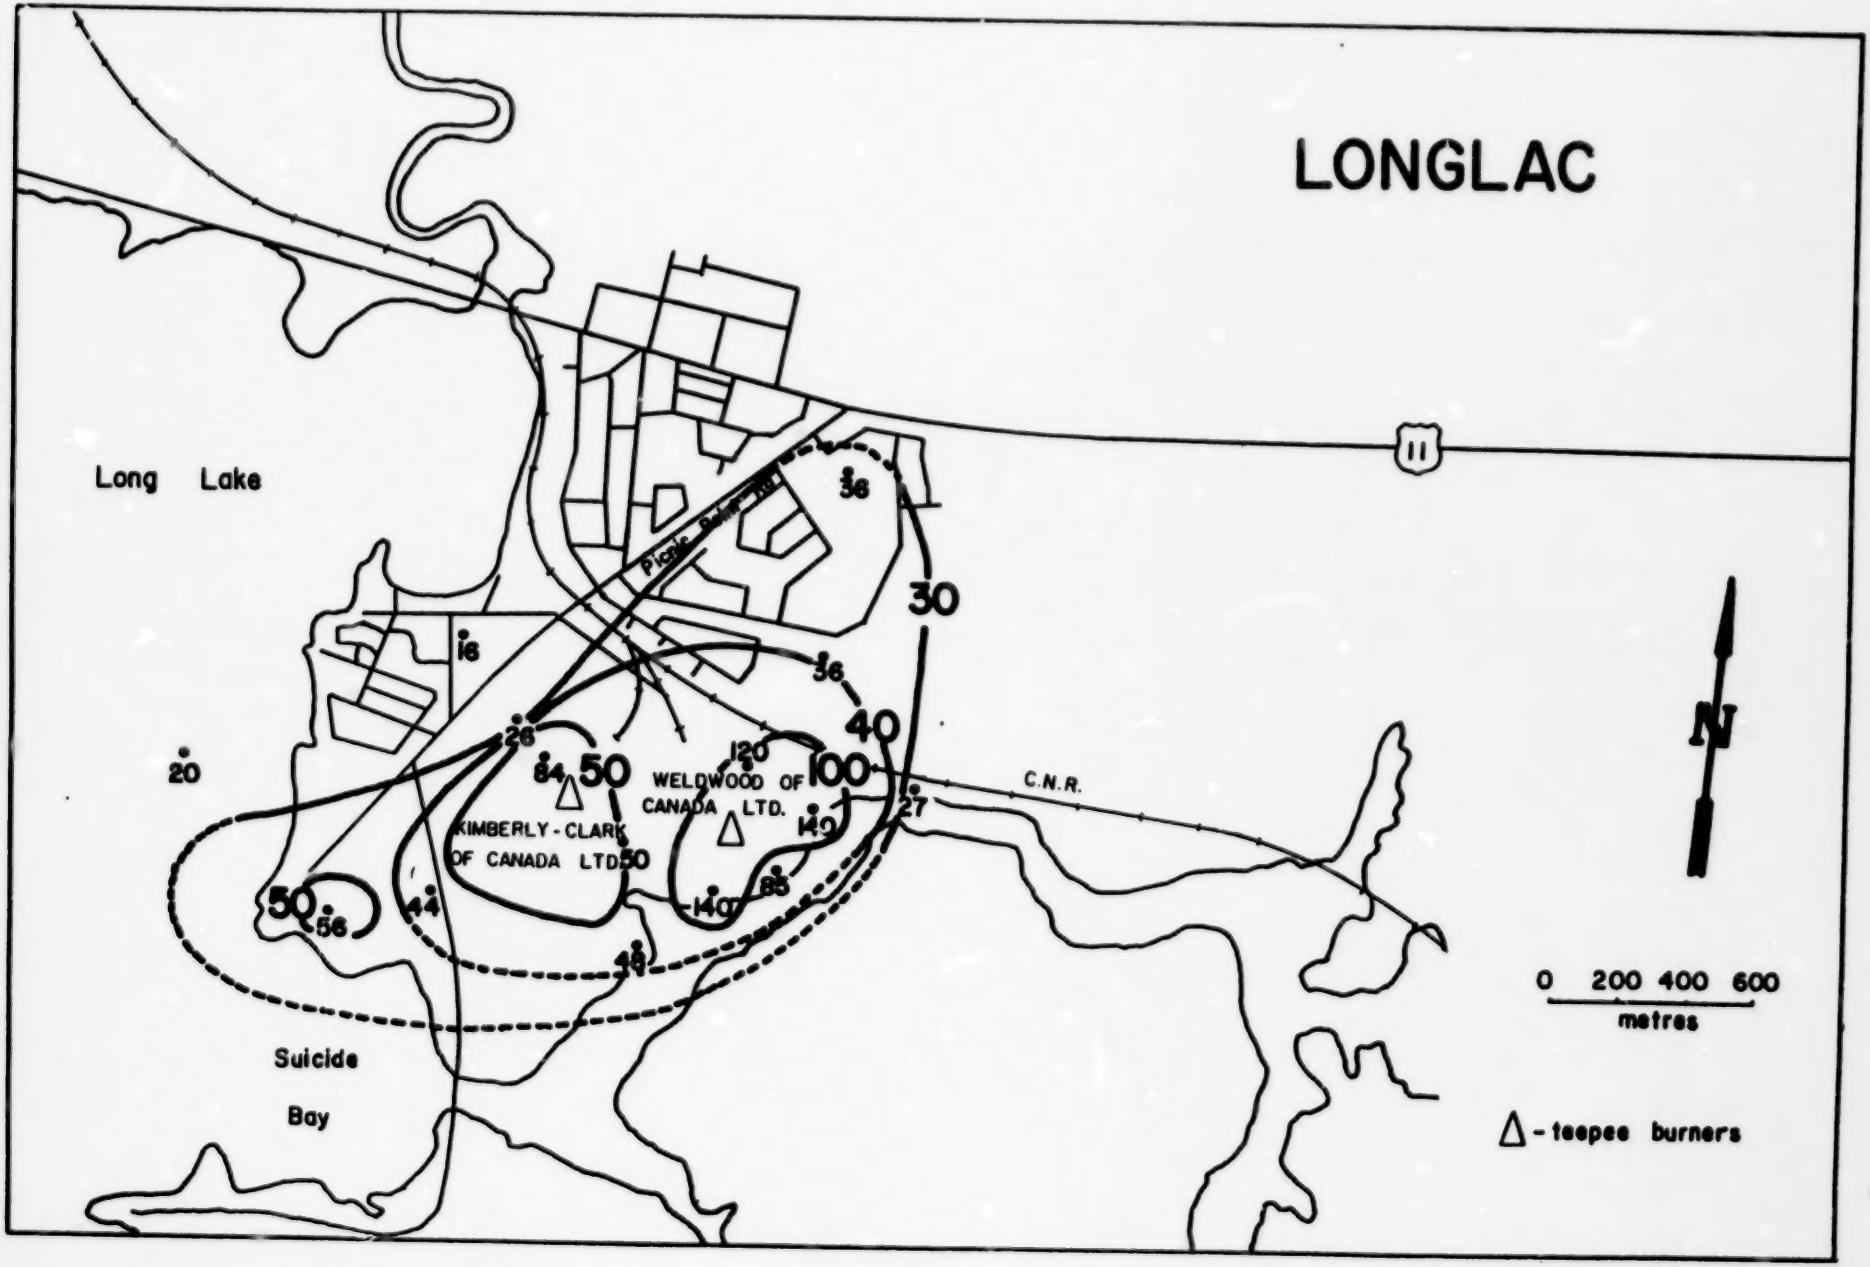
Kimberly-Clark's burner. Levels of tannins were slightly elevated in these two areas. Contaminant concentrations in residential areas, while lower than those near the burners, were still well above background. Trace to heavy quantities of wood fines or charred wood particles were noted in snow or snow meltwater from all sites except sites 8, 14, and the controls. Some of this material was deposited as far as 1,100 metres north of the teepee burners. Microscopic examination identified these particles as primarily wood fibres, with minor amounts of partially combusted wood and bark. These contaminants were distributed in a pattern generally similar to that shown in Figure 2 for suspended solids.

Figure 2. Levels of suspended solids (mg/l) in snow, Longlac, 1983.
